Project Dublin Ireland

The experiments described here aimed to quantify the total bacterial count (TBC) and Molds/Yeasts (M/Y) detected in the Company's offices, located in Dublin, Ireland, by comparing the results obtained in five environments before and after the installation of lighting systems equipped with Biovitae® continuous sanitization technology.

Description of the tested environments

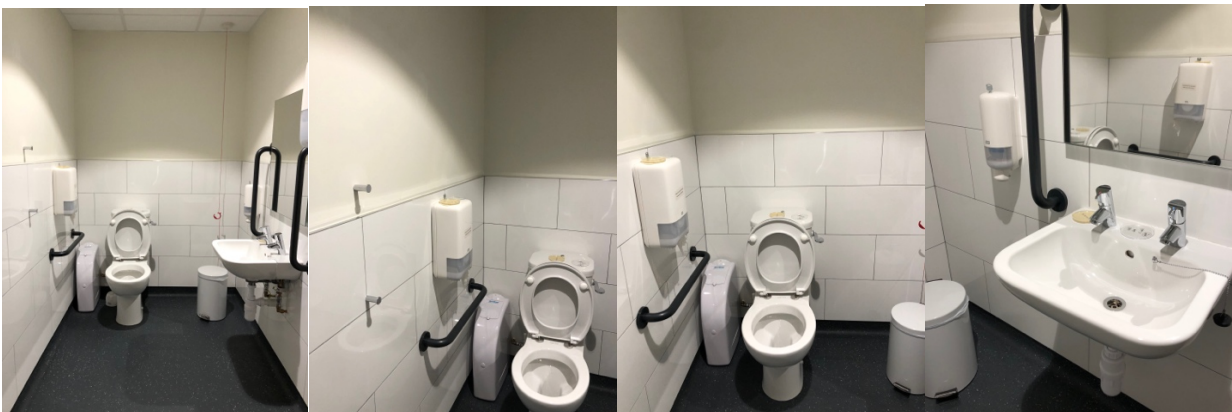
Bathroom 1 (Room 4)

The two bathrooms are located on the ground floor of the building, in a corridor with no windows or access to or from the outside. The floor is covered in non-slip plastic material. The walls are covered with white tiles and cement joints for a height of about 120 cm while the rest of the wall is painted with washable paint. The automatic ventilation system is installed in the false ceiling.

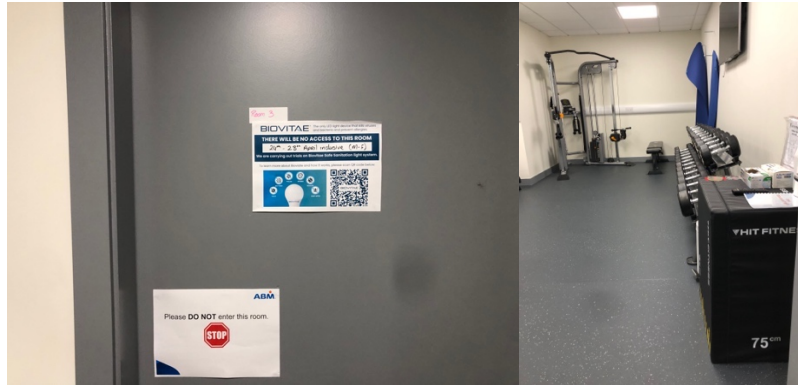
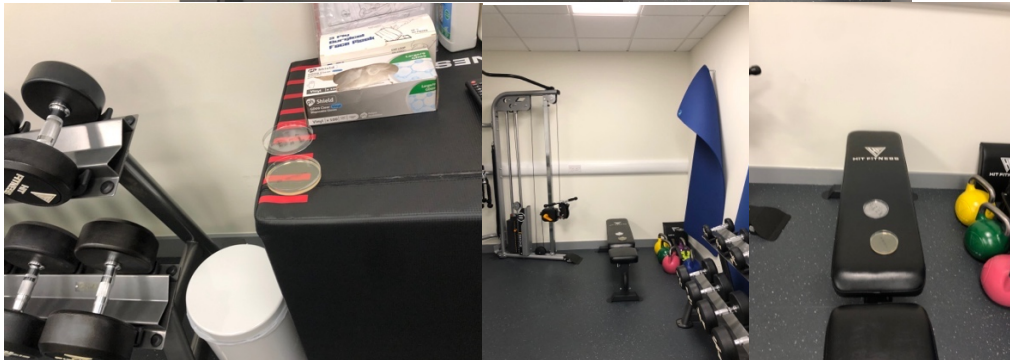
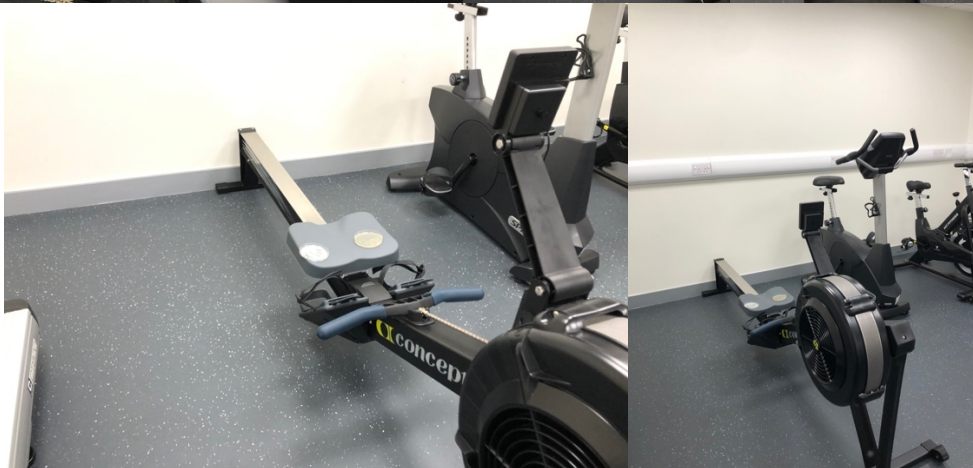
Gym (room 3)

The room used as a gym is located on the first floor of the building. It has only one entrance door and no access to or from the outside or windows. The floor is covered in non-slip plastic material. The walls are painted with washable paint. The automatic ventilation system is installed in the false ceiling.

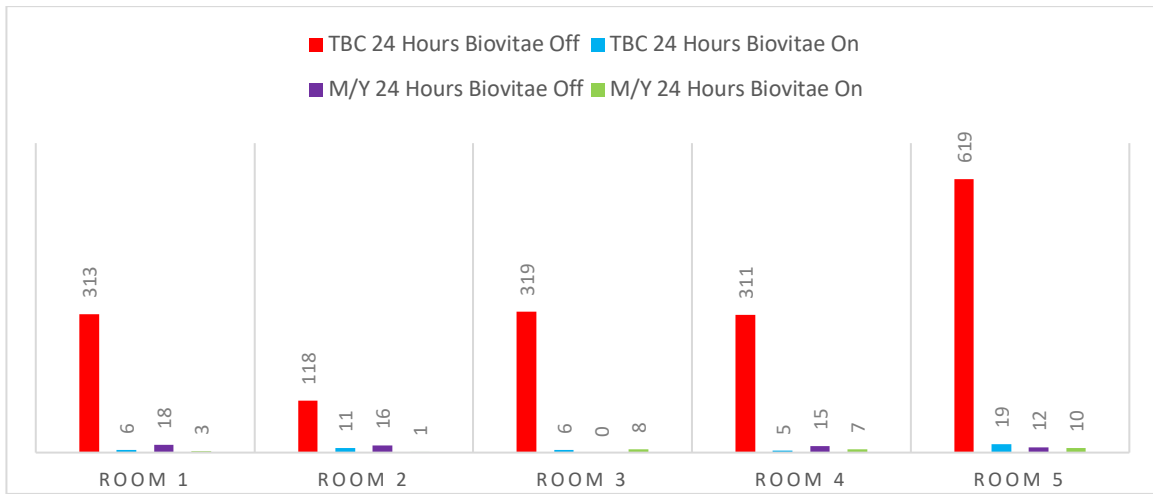
Fig. 1 - Comparing the TBC in the first half of 24 hours testing.

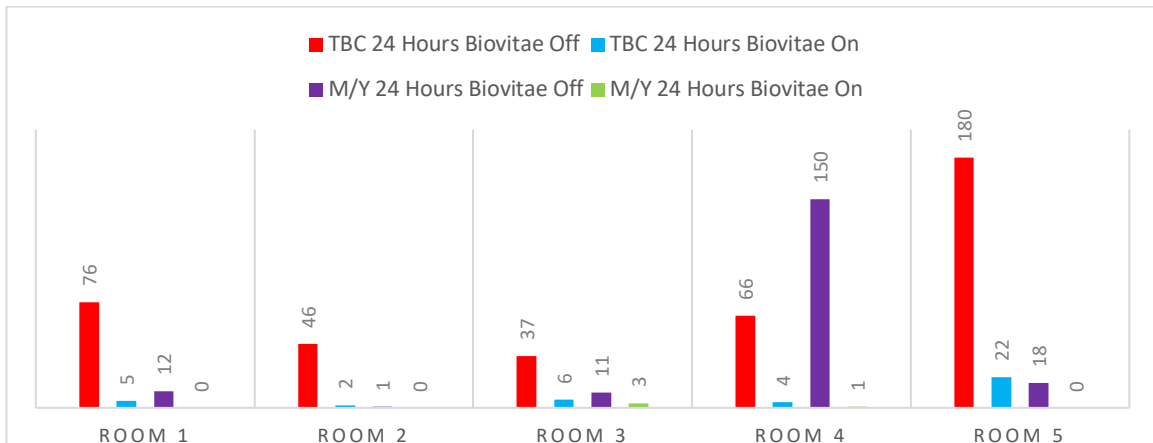
Fig. 2 - Comparing the TBC in the second half of 24 hours testing.

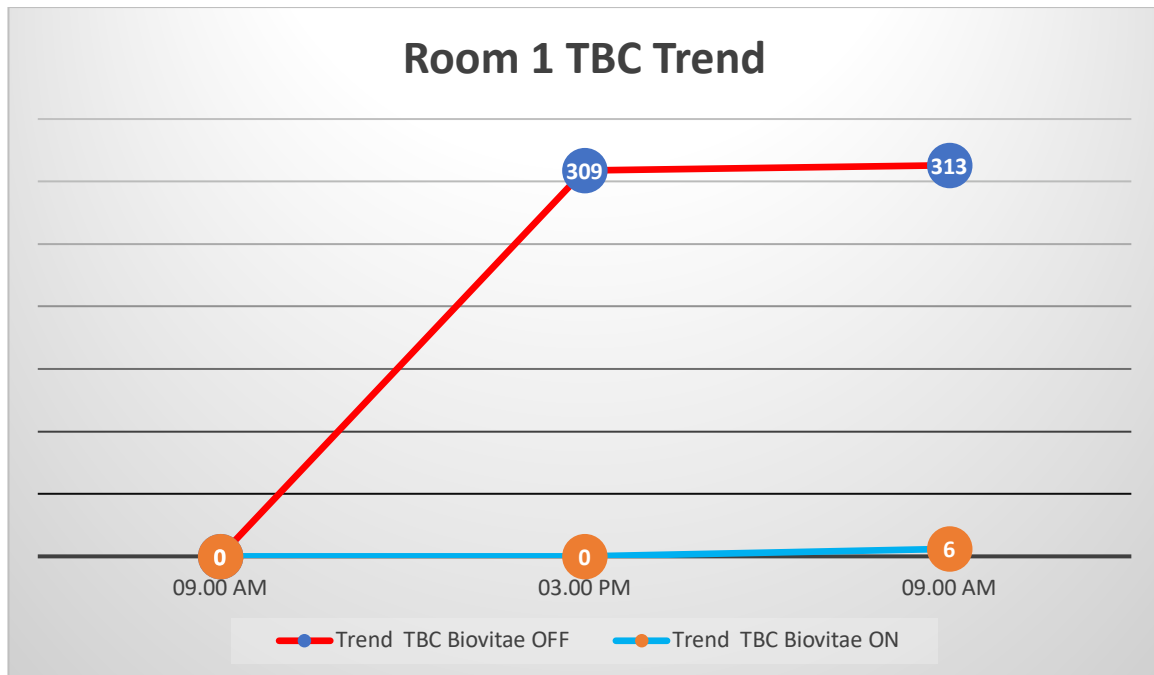
Fig. 3 - ROOM 1, TEST 1 (TBC: -98.10%): comparing the TBC trends in Meeting Room 1 (Room 1), before and after installation of Biovitae® light sources. Under standard lighting, the TBC has an exponential trend in the first hours and then continues to grow. Under Biovitae® lighting, TBC count is always very low and does not present phases of uncontrolled growth.

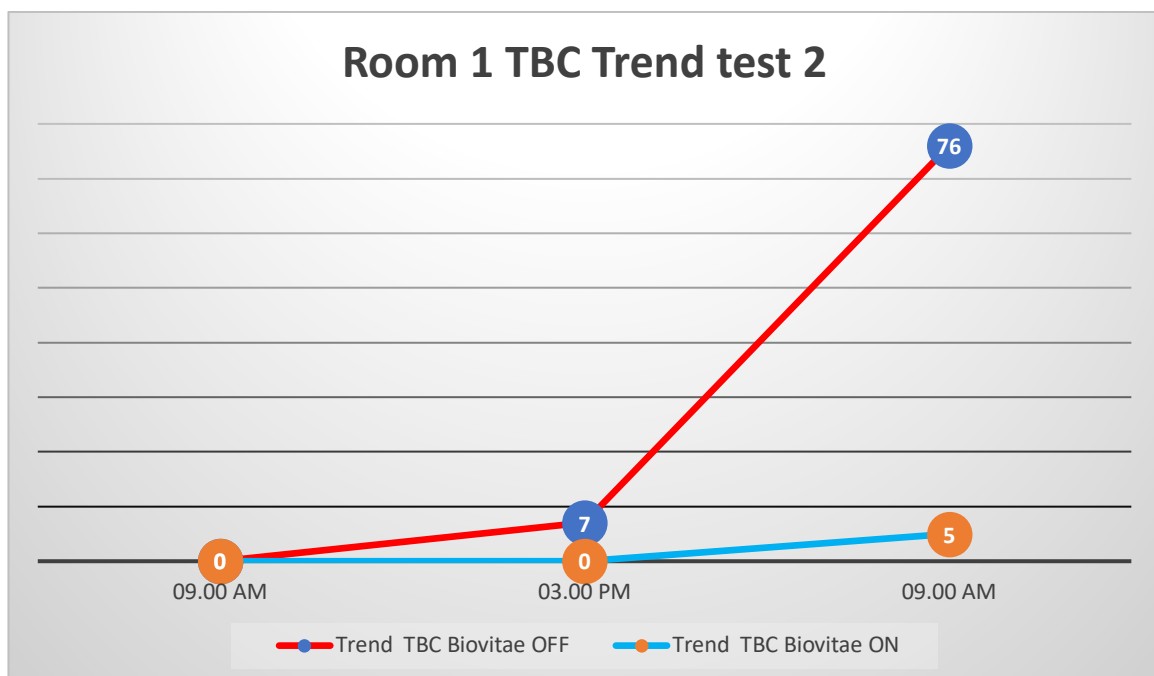
Fig. 4 - ROOM 1, TEST 2 (TBC: -93.42%): comparing TBC trends in Meeting Room 1 (Room 1), before and after installation of Biovitae® light sources. Under standard lighting, the TBC has an exponential trend in the first hours and then continues to grow. Under Biovitae® lighting, TBC count is always very low and does not present phases of uncontrolled growth.

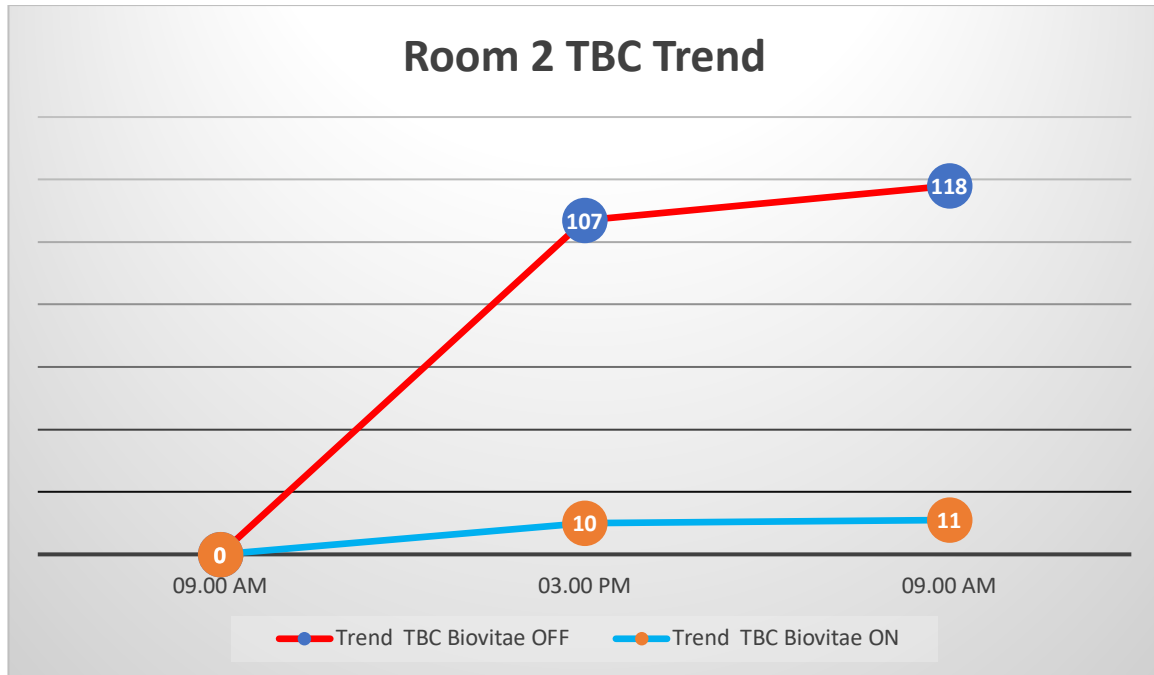
Fig. 5 - ROOM 2, TEST 1 (TBC: -90.67%): comparing TBC trends in Meeting Room 2 (Room 2), before and after installation of Biovitae® light sources. Under standard lighting, the TBC has an exponential trend in the first hours and then continues to grow. Under Biovitae® lighting, TBC count is always very low and does not present phases of uncontrolled growth.

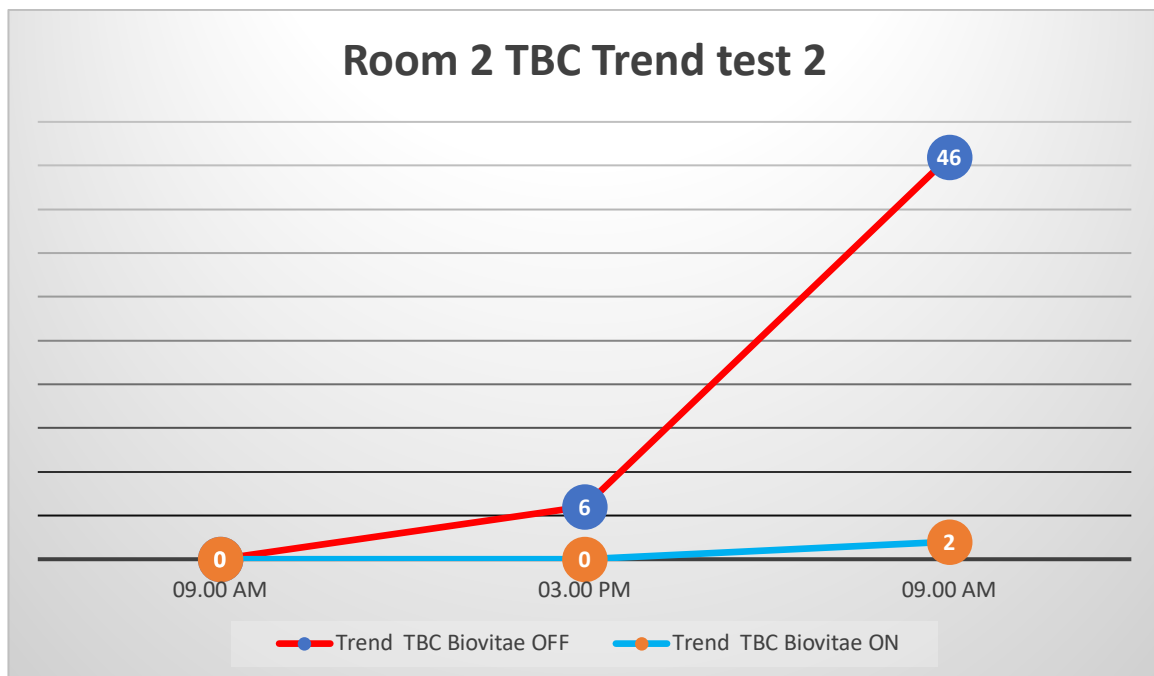
Fig.6 - ROOM 2, TEST 2 (TBC: -95.65%): comparing TBC trends in Meeting Room 2 (Room 2), before and after installation of Biovitae® light sources. Under standard lighting, the TBC has an exponential trend in the first hours and then continues to grow. Under Biovitae® lighting, TBC count is always very low and does not present phases of uncontrolled growth.

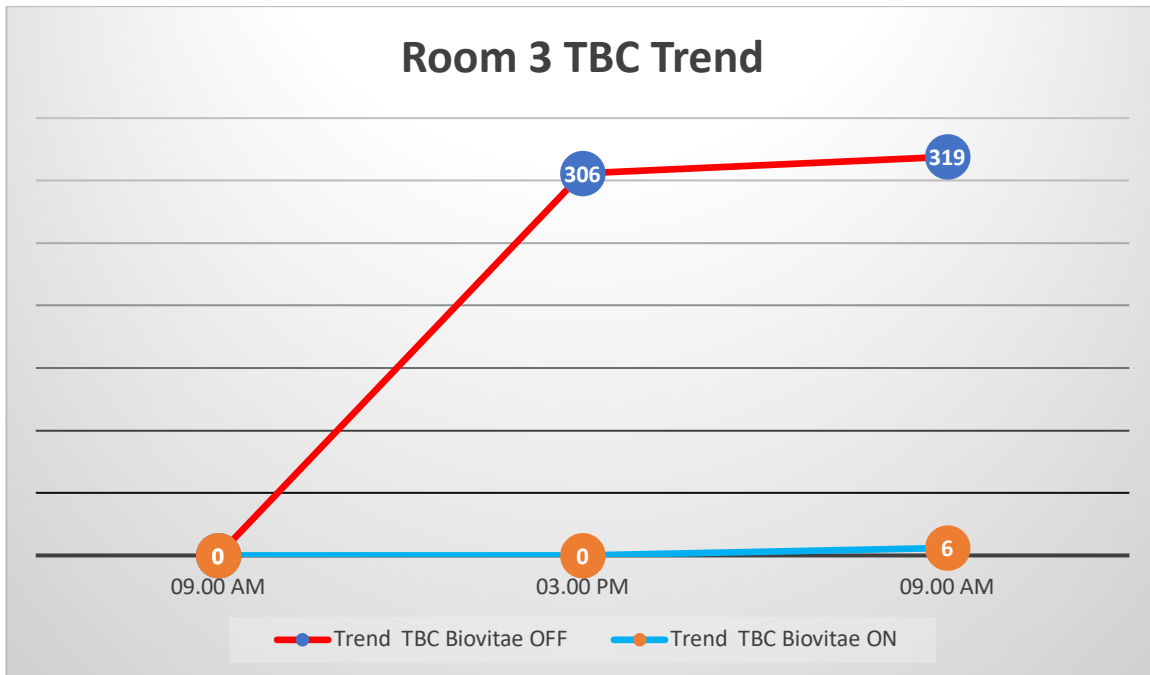
Fig. 7 - ROOM 3, TEST 1 (TBC: -98.11%): comparing TBC trends in the Gym (Room 3), before and after installation of Biovitae® light sources. Under standard lighting, the TBC has an exponential trend in the first hours and then continues to grow. Under Biovitae® lighting, TBC count is always very low and does not present phases of uncontrolled growth.

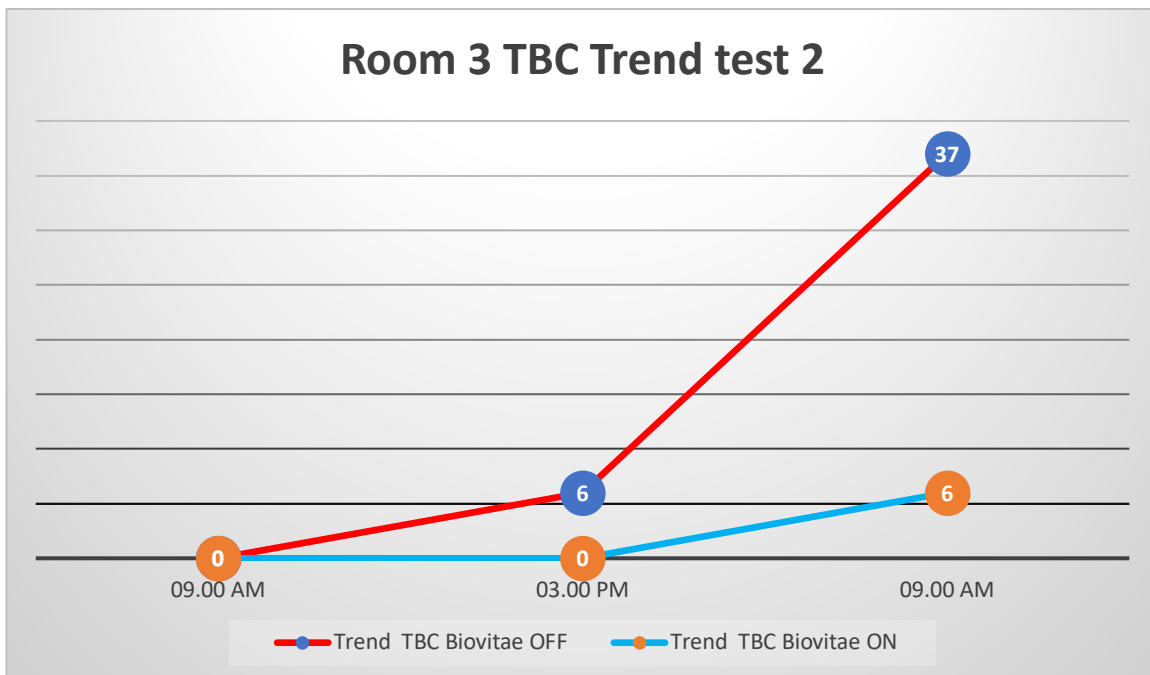
Fig. 8 - ROOM 3, TEST 2 (TBC: -83.78%): comparing TBC trends in the Gym (Room 3), before and after installation of Biovitae® light sources. Under standard lighting, the TBC has an exponential trend in the first hours and then continues to grow. Under Biovitae® lighting, TBC count is always very low and does not present phases of uncontrolled growth.

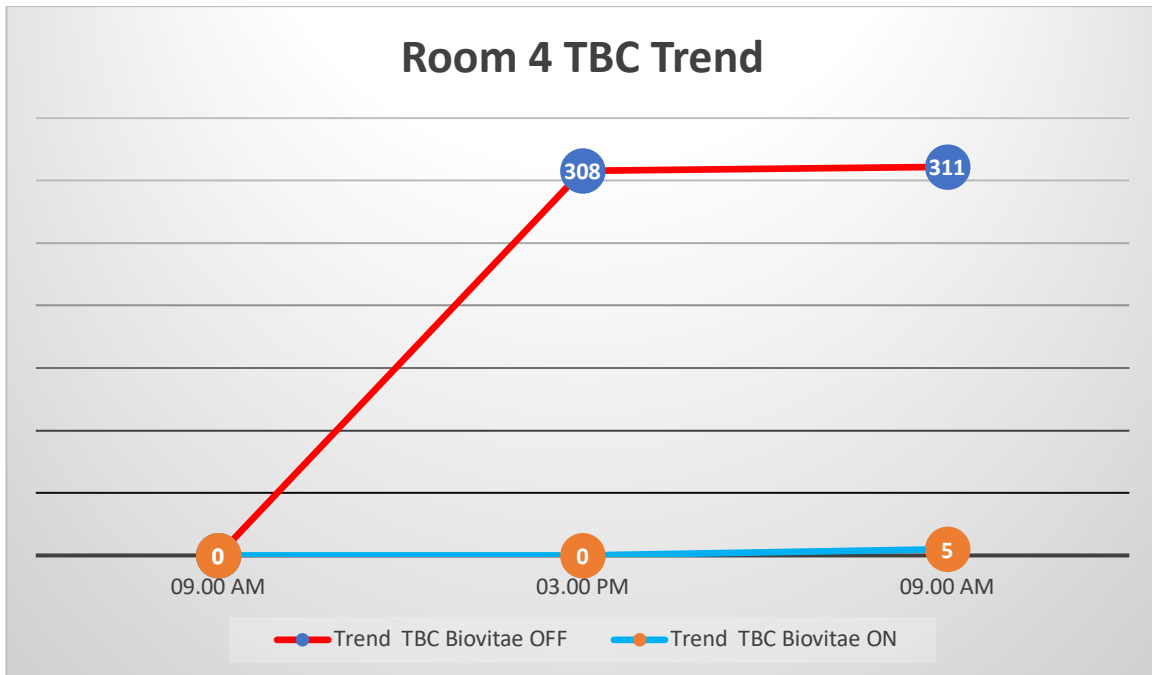
Fig. 9 - ROOM 4, TEST 1 (TBC: -98.39%): comparing TBC trends in Bathroom 1 (Room 4), before and after installation of Biovitae® light sources. Under standard lighting, the TBC has an exponential trend in the first hours and then continues to grow. Under Biovitae® lighting, TBC count is always very low and does not present phases of uncontrolled growth.

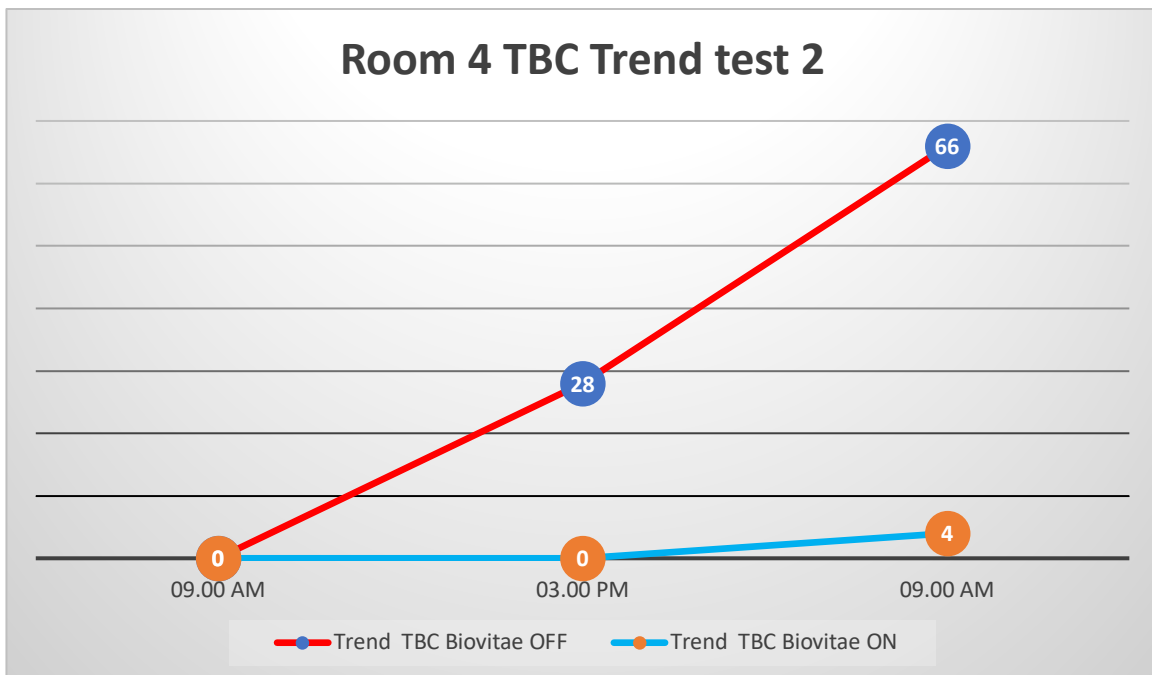
Fig. 10 - ROOM 4, TEST 2 (TBC: -93.93%): comparing TBC trends in Bathroom 1 (Room 4), before and after installation of Biovitae® light sources. Under standard lighting, the TBC has an exponential trend in the first hours and then continues to grow. Under Biovitae® lighting, TBC count is always very low and does not present phases of uncontrolled growth.

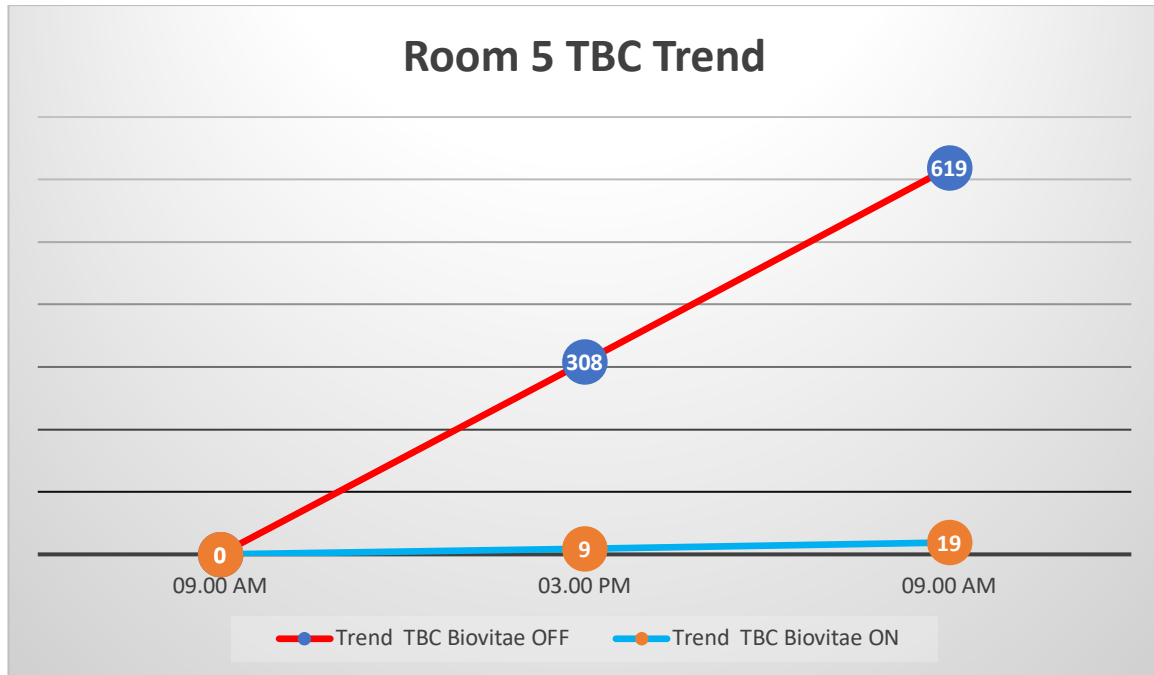
Fig. 11 - ROOM 5, TEST 1 (TBC: -96.30%): comparing of TBC trends in Bathroom 2 (Room 5), before and after installation of Biovitae® light sources. Under standard lighting, the TBC has an exponential trend in the first hours and then continues to grow. Under Biovitae® lighting, TBC count is always very low and does not present phases of uncontrolled growth.

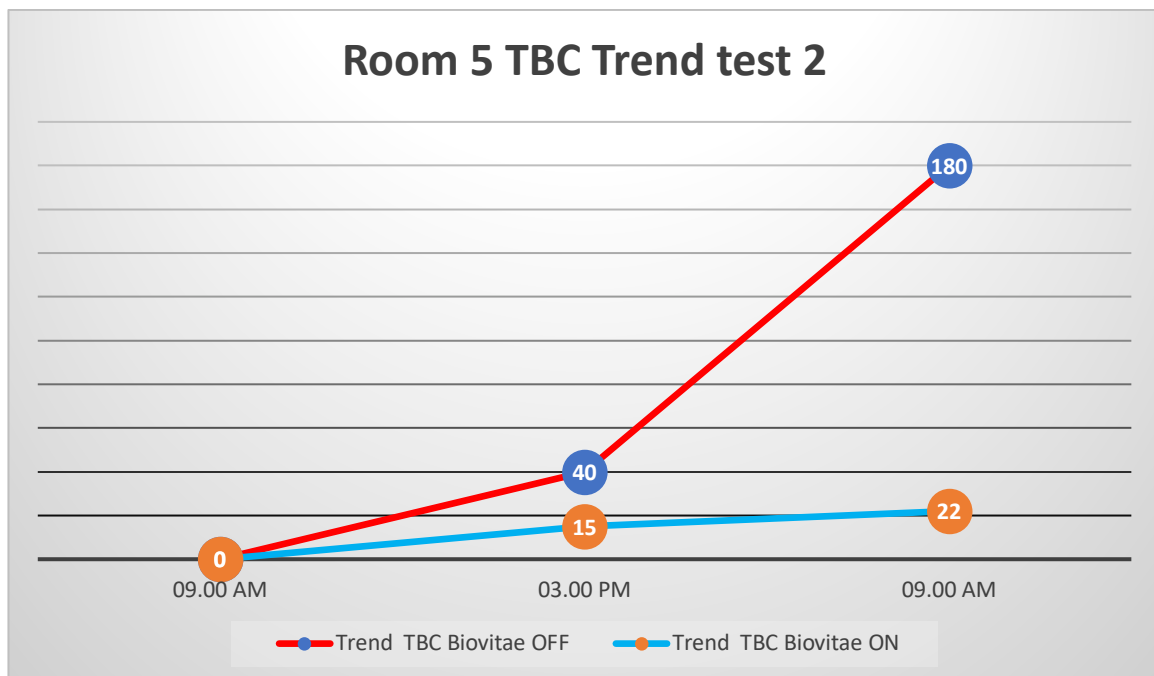
Fig. 12 - ROOM 5, TEST 2 (TBC: -87.77%): comparing of TBC trends in Bathroom 2 (Room 5), before and after installation of Biovitae® light sources. Under standard lighting, the TBC has an exponential trend in the first hours and then continues to grow. Under Biovitae® lighting, TBC count is always very low and does not present phases of uncontrolled growth.

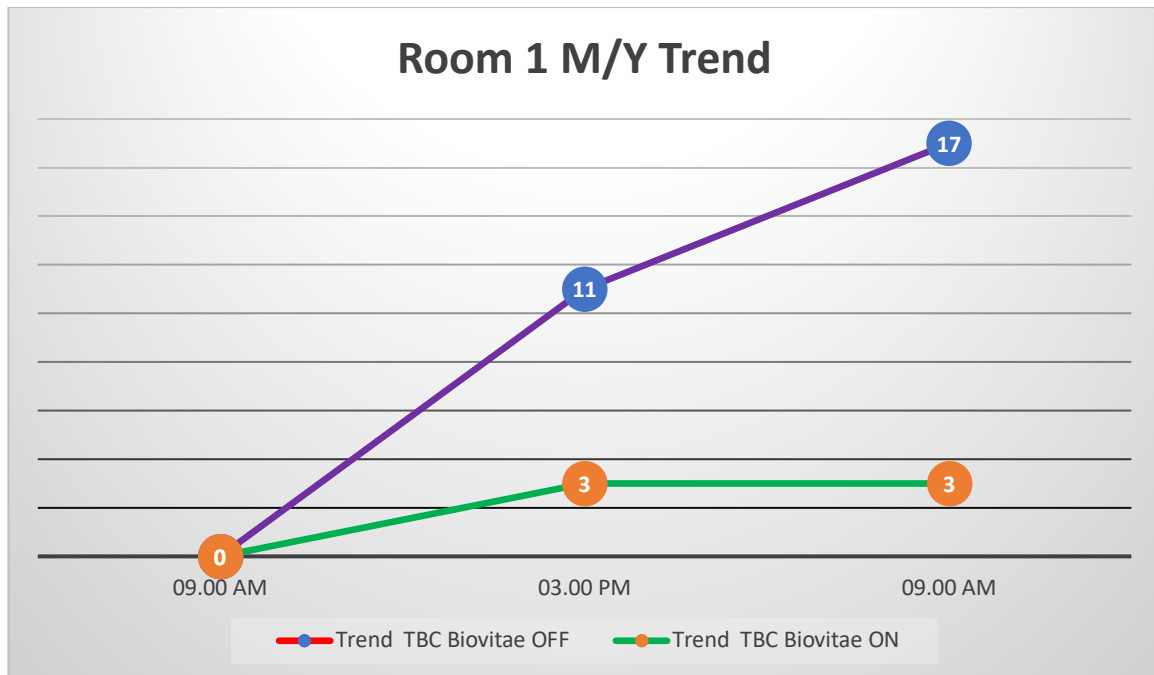
Fig. 13 - ROOM 1, TEST 1 (Y/M: -82.35%): comparing of M/Y trends in Meeting Room 1 (Room 1), before and after installation of Biovitae® light sources. Under standard lighting, the Y/M count has an exponential trend in the first hours and then continues to grow. Under Biovitae® lighting, Y/M count is always very low and does not present phases of uncontrolled growth.

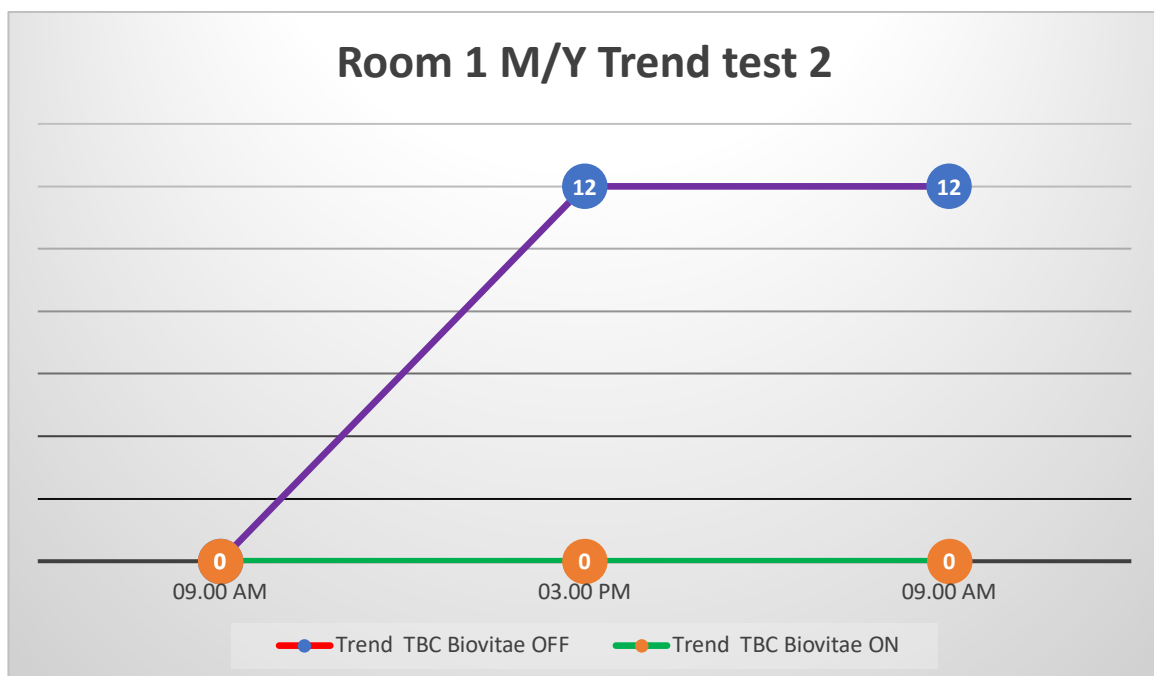
Fig. 14 - ROOM 1, TEST 2 (Y/M: -100.00%): comparing of M/Y trends in Meeting Room 1 (Room 1), before and after installation of Biovitae® light sources. Under standard lighting, the Y/M count has an exponential trend in the first hours and then continues to grow. Under Biovitae® lighting, Y/M count is always very low and does not present phases of uncontrolled growth.

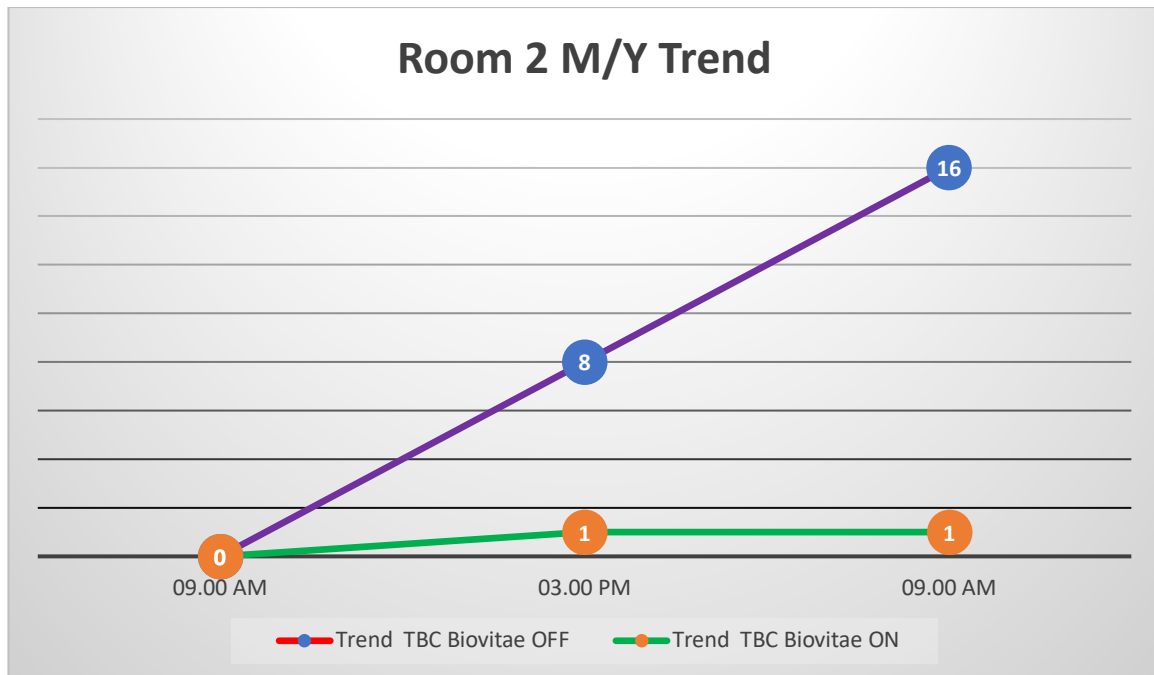
Fig. 15 - ROOM 2, TEST 1 (Y/M: -93.75%): comparing of M/Y trends in Meeting Room 2 (Room 2), before and after installation of Biovitae® light sources. Under standard lighting, the Y/M count has an exponential trend in the first hours and then continues to grow. Under Biovitae® lighting, Y/M count is always very low and does not present phases of uncontrolled growth.

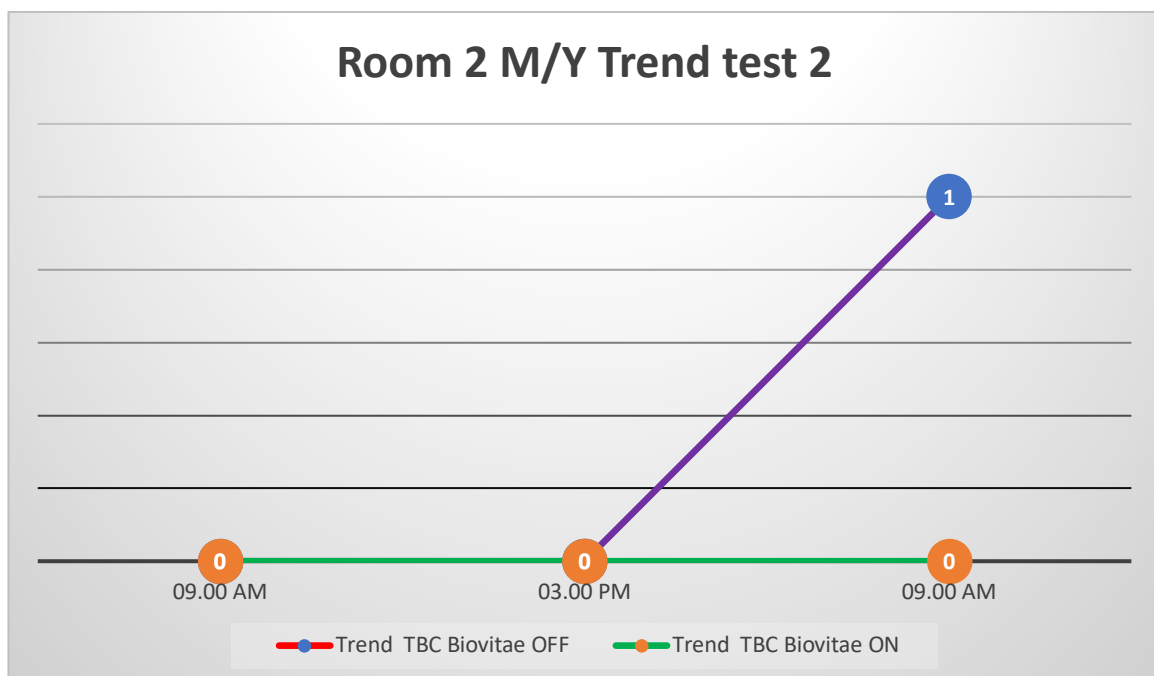
Fig. 16 - ROOM 2, TEST 2 (Y/M: -100.00%): comparing of M/Y trends in Meeting Room 2 (Room 2), before and after installation of Biovitae® light sources. Under standard lighting, the Y/M count has an exponential trend in the first hours and then continues to grow. Under Biovitae® lighting, Y/M count is always very low and does not present phases of uncontrolled growth.

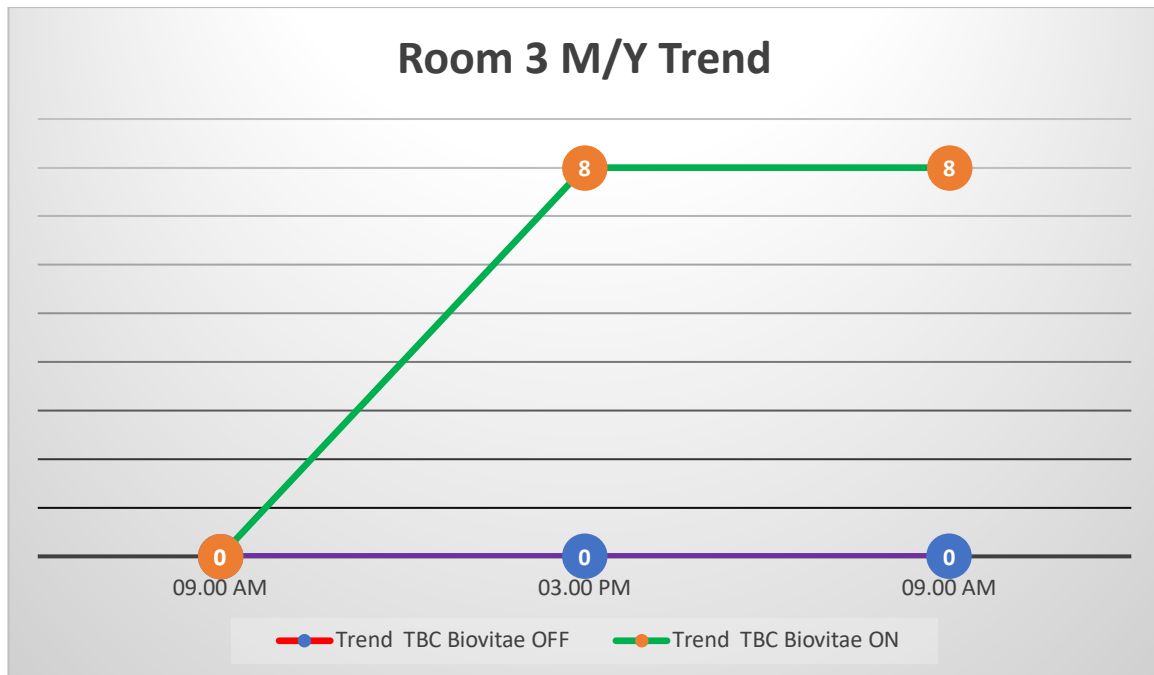
Fig. 17 - ROOM 3, TEST 1 (Y/M: -100.00%): comparing of M/Y trends in the Gym (Room 3), before and after installation of Biovitae® light sources. Under standard lighting, the Y/M count has an exponential trend in the first hours and then continues to grow. Under Biovitae® lighting, Y/M count is always very low and does not present phases of uncontrolled growth.

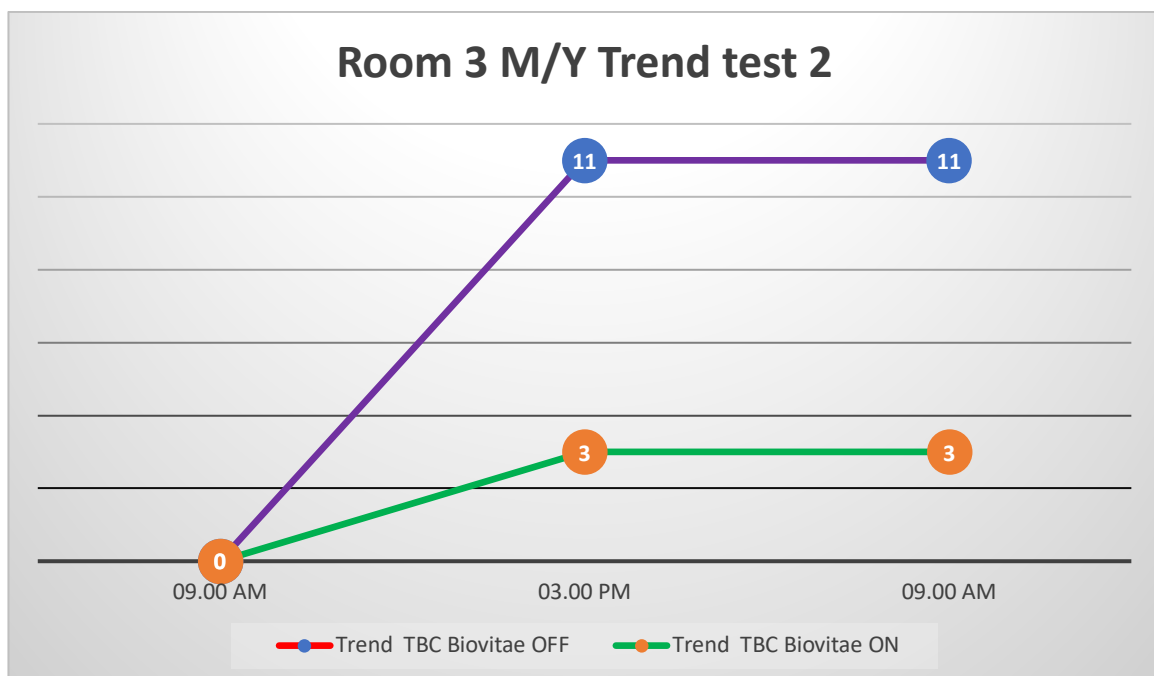
Fig. 18 - ROOM 3, TEST 2 (Y/M: -72.72%): comparing of M/Y trends in the Gym (Room 3), before and after installation of Biovitae® light sources. Under standard lighting, the Y/M count has an exponential trend in the first hours and then continues to grow. Under Biovitae® lighting, Y/M count is always very low and does not present phases of uncontrolled growth.

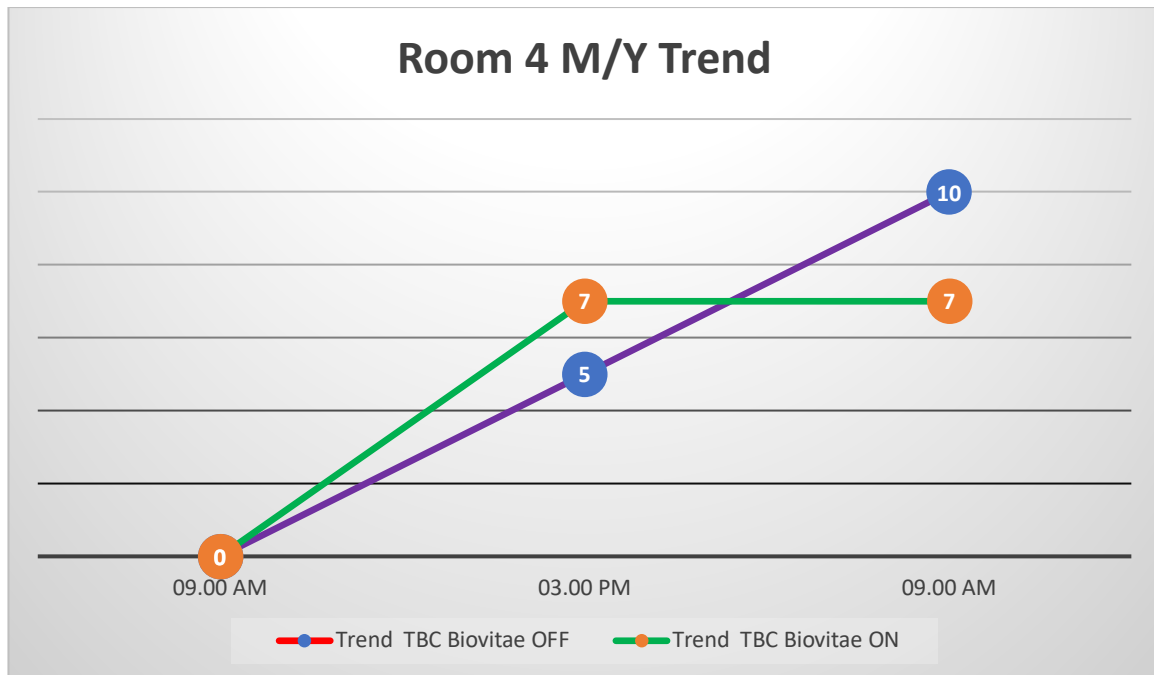
Fig. 19 - ROOM 4, TEST 1 (Y/M: -30.00%): comparing of M/Y trends in Bathroom 1 (Room 4), before and after installation of Biovitae® light sources. In this round the total M/Y count is higher in the immediate after installation, most likely following the technical problems during the assembly of the Biovitae® light sources which required a very long time and the need to remove numerous tiles, resulting in direct contamination of the environment through material precipitated from the ceiling.

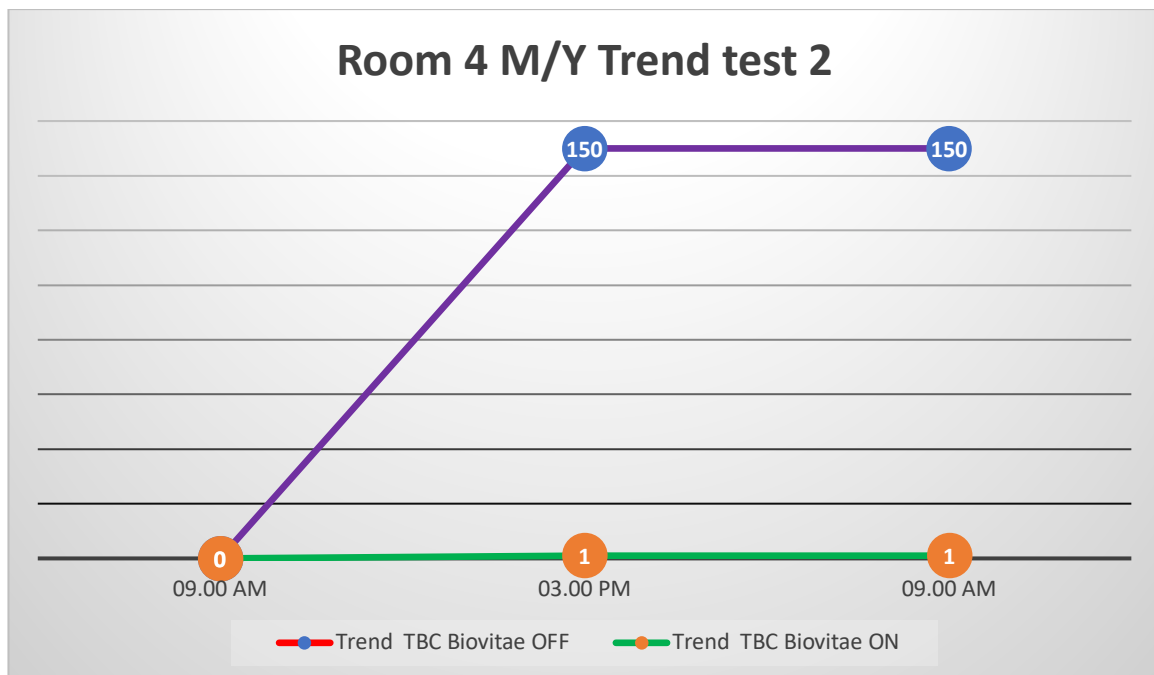
Fig. 20 - ROOM 4, TEST 2 (Y/M: -99.33%): comparing of M/Y trends in Bathroom 1 (Room 4), before and after installation of Biovitae® light sources. Under standard lighting, the Y/M count has an exponential trend in the first hours and then continues to grow. Under Biovitae® lighting, Y/M count is always very low and does not present phases of uncontrolled growth.

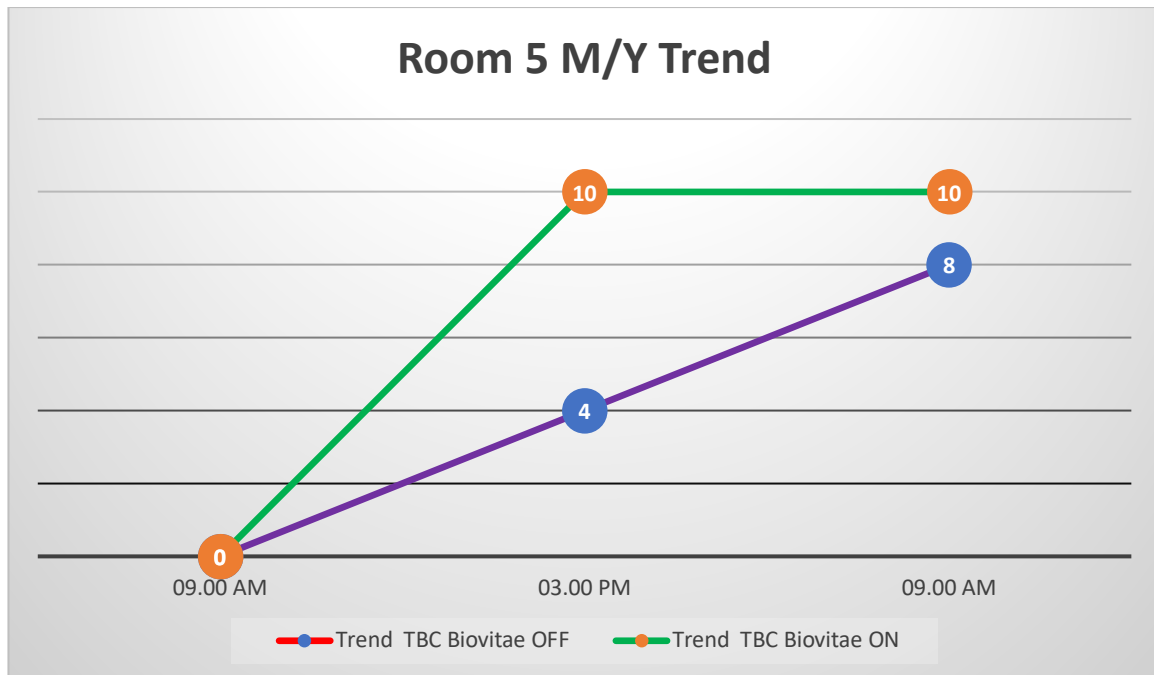
Fig. 21 - ROOM 5, TEST 1 (Y/M: -20.00%): comparing of M/Y trends in Bathroom 2 (Room 5), before and after installation of Biovitae® light sources. Again, in this round the total M/Y count is higher in the immediate after installation, most likely following the technical problems during the assembly of the Biovitae® light sources which required a very long time and the need to remove numerous tiles, resulting in direct contamination of the environment through material precipitated from the ceiling.

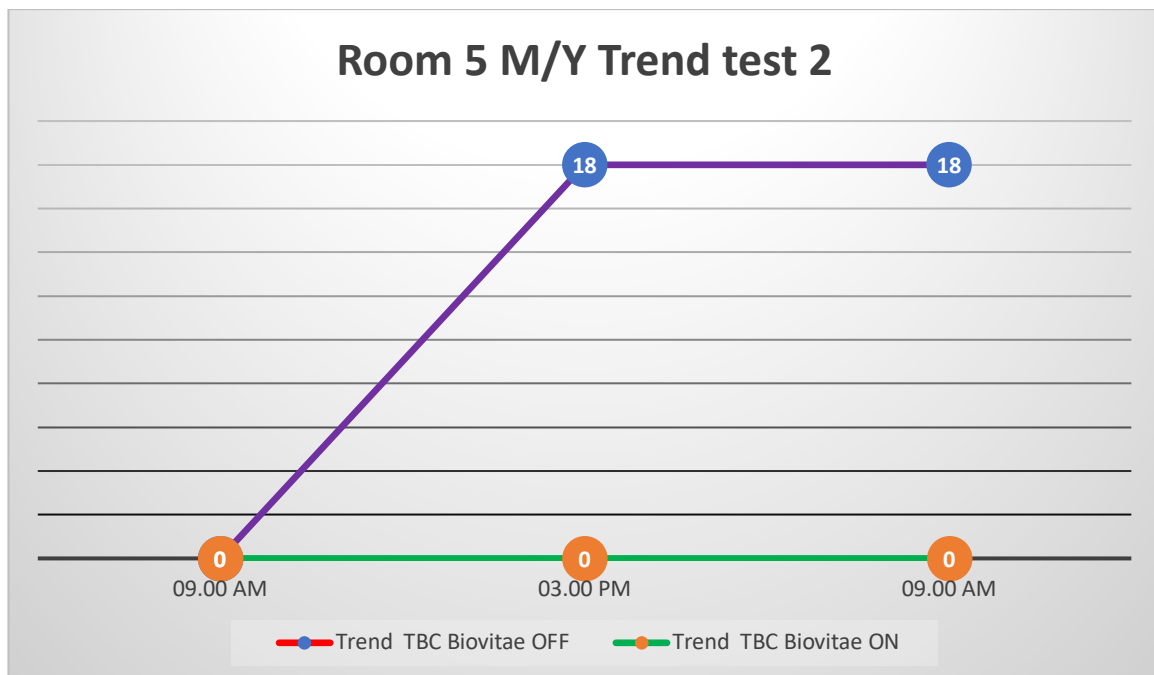
Fig. 22 - ROOM 5, TEST 2 (Y/M: -100.00%): comparing of M/Y trends in Bathroom 2 (Room 5), before and after installation of Biovitae® light sources. Under standard lighting, the Y/M count has an exponential trend in the first hours and then continues to grow. Under Biovitae® lighting, Y/M count is always very low and does not present phases of uncontrolled growth.
